# Safety Share – Fire Extinguisher Explosion

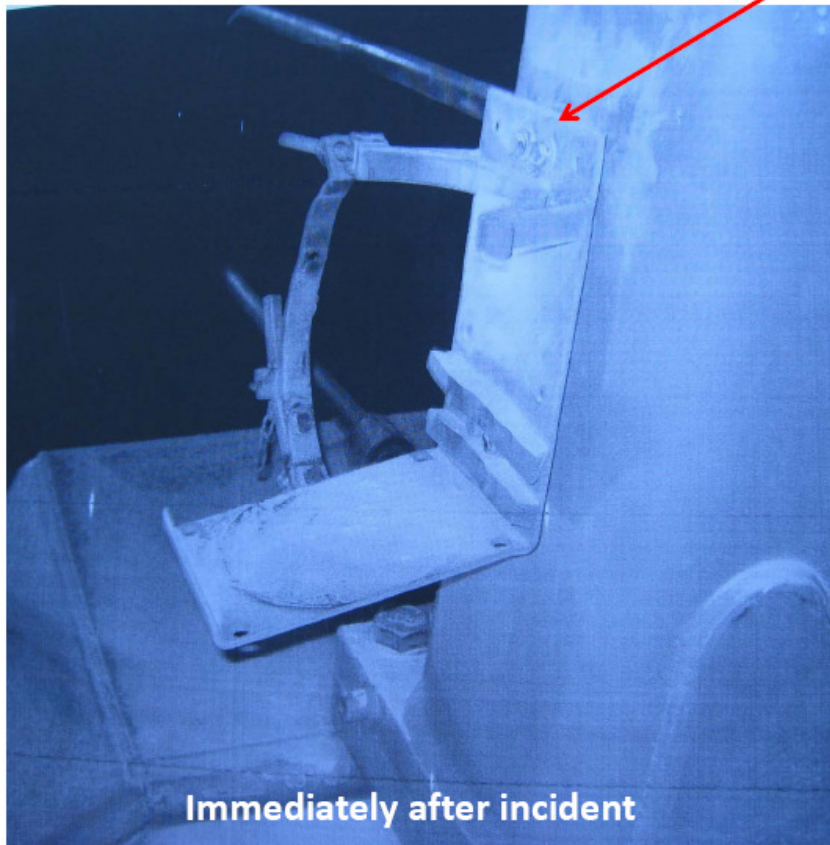
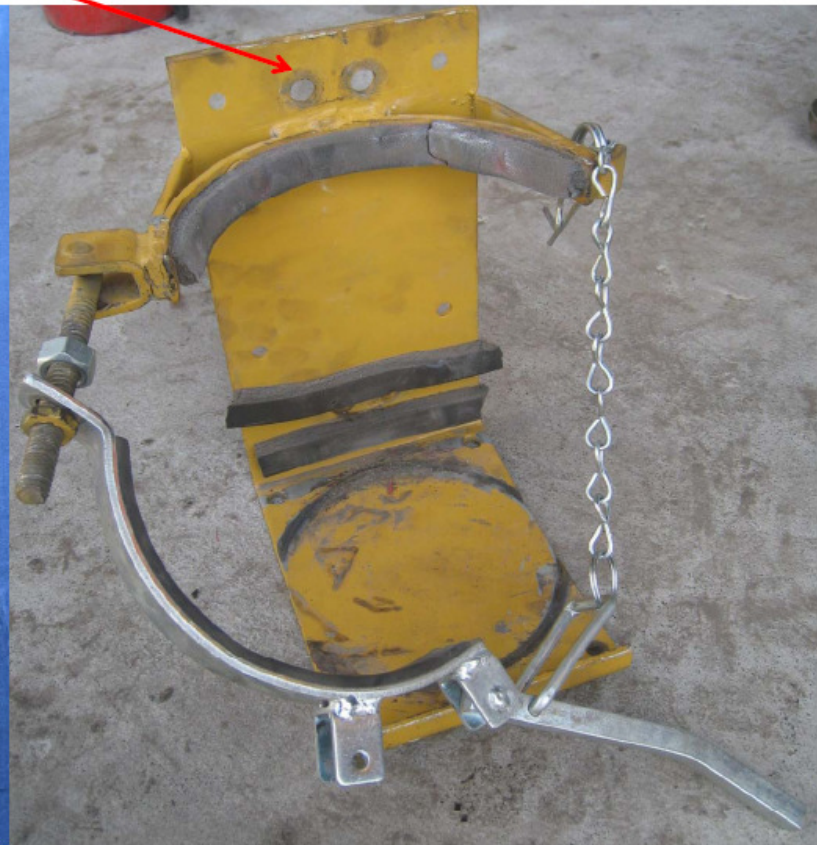
Arrows point to bolt location

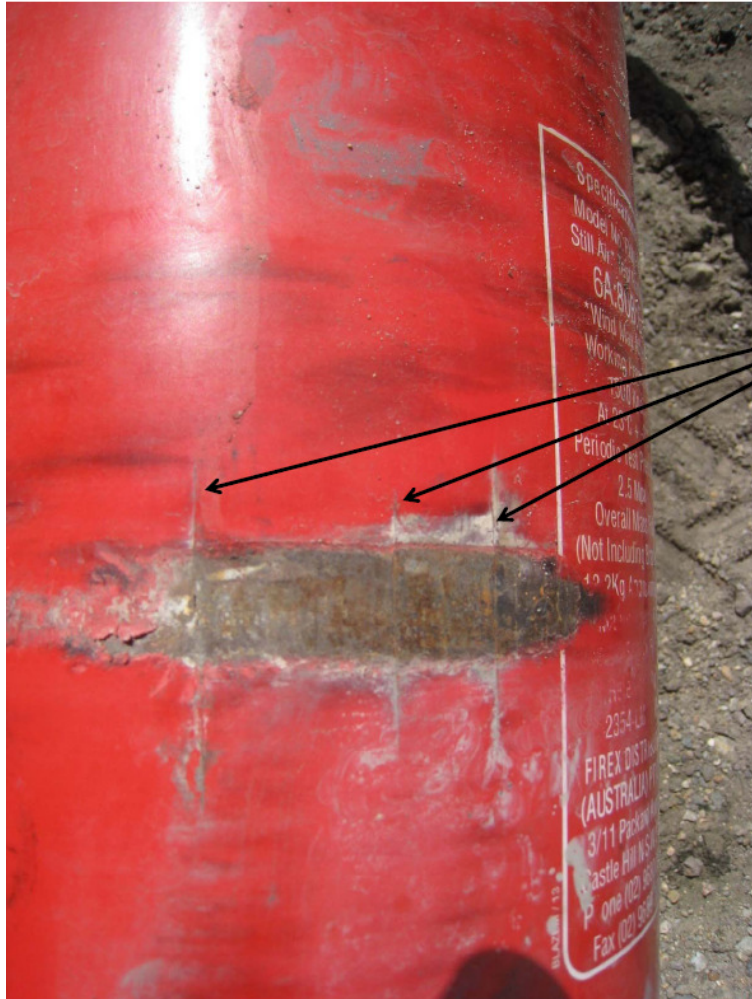
Fatigue cracking

Third extinguisher showing wear from bracket strap rubbing

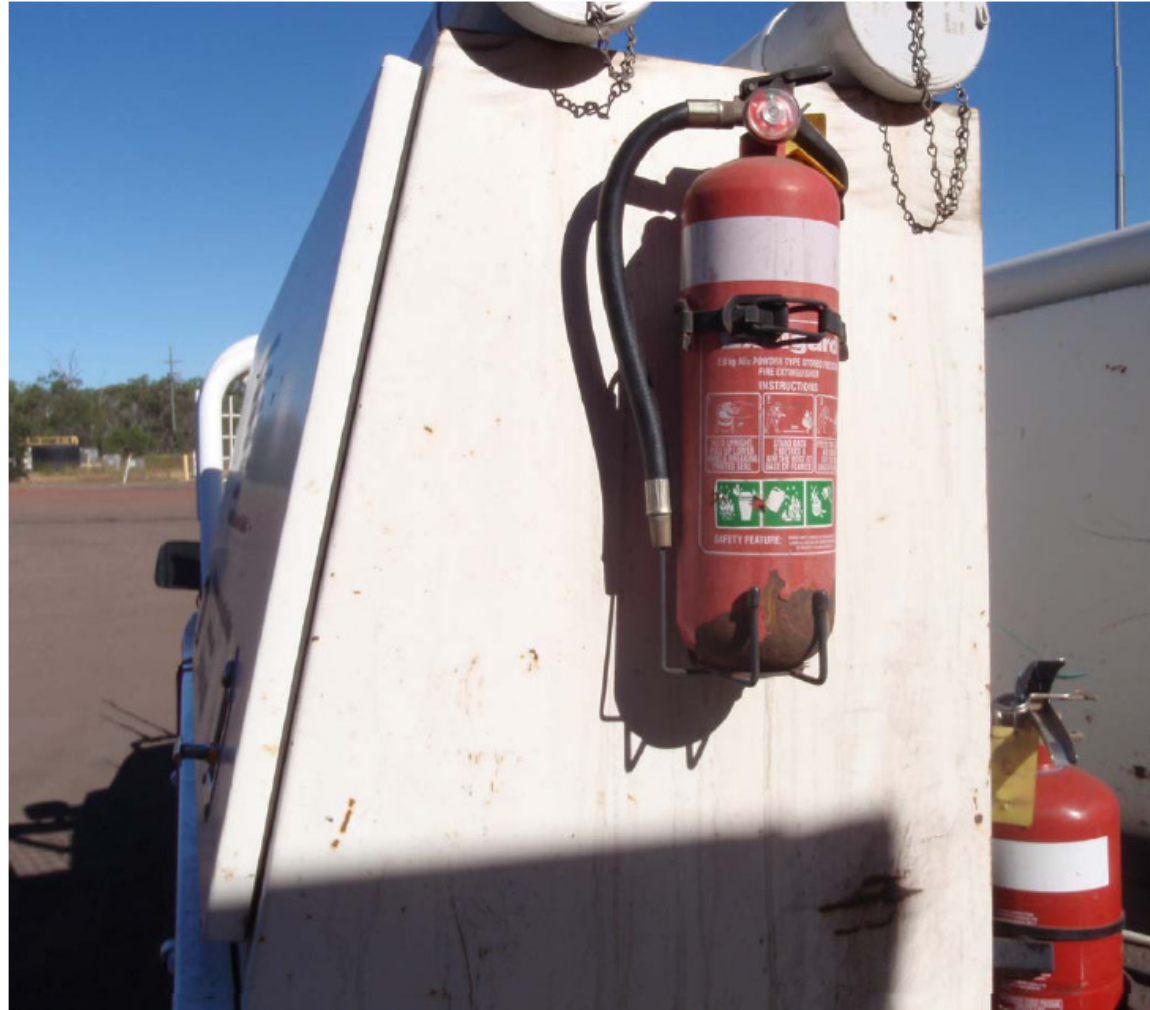
Burton – Checks found this FE with a corroded base – another potential bomb!
